Odd Fellows Hall

63-65 Warren Avenue, East Providence, RI
Historic Structure Assessment

June 2014

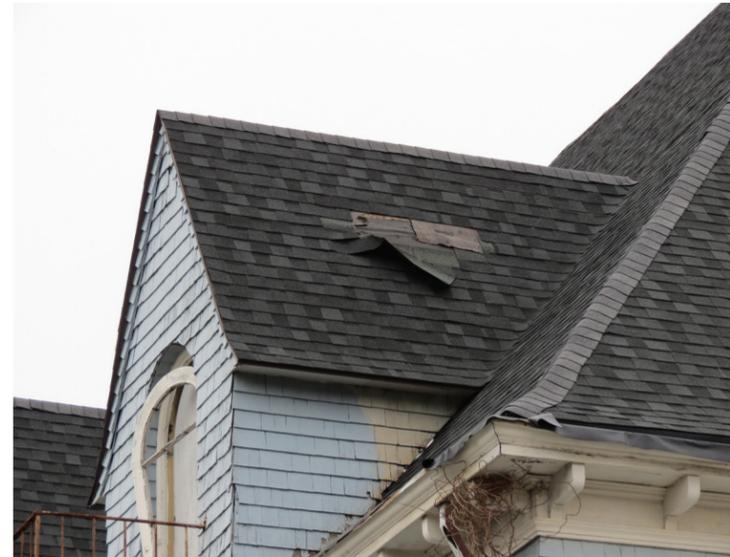
The existing asphalt shingle roof is in very poor condition with shingles missing in some locations. It is evident that the missing shingles have allowed water to penetrate the building envelope and have caused the wood roof deck to deteriorate. The deterioration of the roof deck is so extensive that holes have opened into the attic space. The water that has entered through these holes has caused deterioration and failure of interior wood floor framing systems.

Non-original asphalt shingle roof. View looking south at dormers of east elevation.

Remove the existing asphalt shingled roof and all deteriorated roof decking. Infill roof decking as required and install new plywood roof sheathing over the entire roof. Install new laminated asphalt shingles. As part of this task, the wood gutters should be restored and all flashings and rain leaders should be replaced.

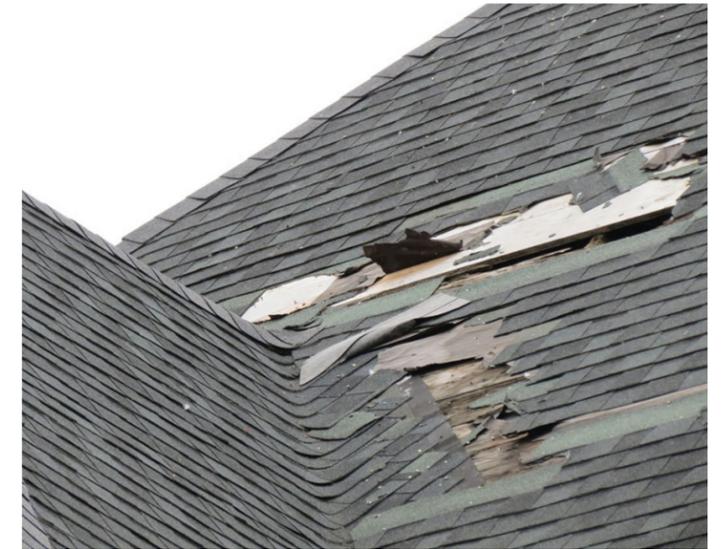
Missing asphalt shingles have left roof deck exposed. View looking south at north elevation.

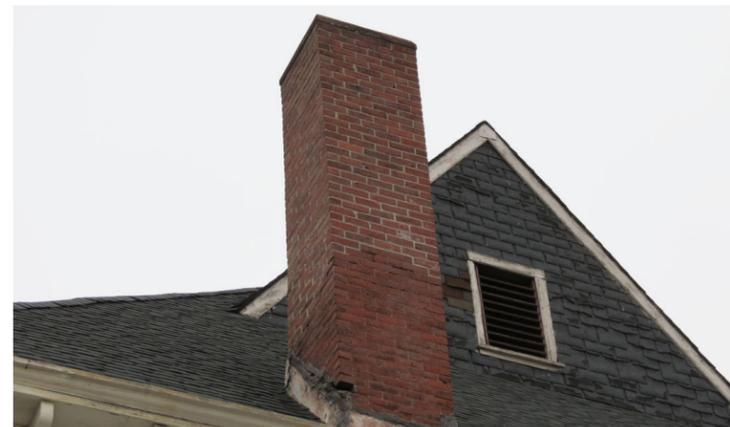
The chimney at the south elevation exhibits signs of previous repointing campaigns at the top portion. There is visible erosion of mortar joints at the base of the chimney as well as missing bricks. The base flashing surrounding the chimney is in poor condition and shows many signs of sealant repairs.

Original chimney at south elevation. View looking north.

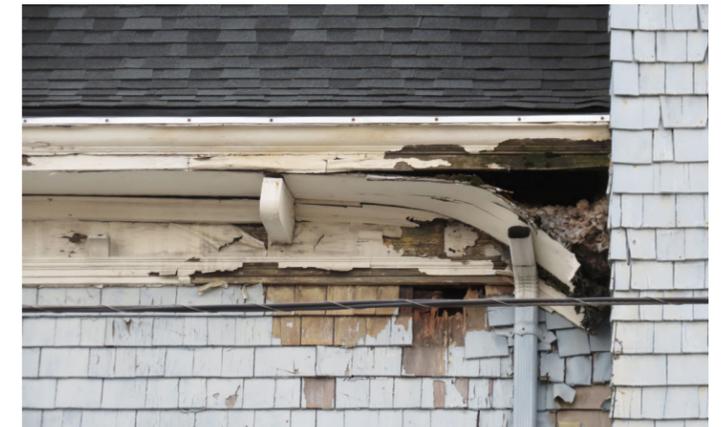
The wood built-in gutter system appears to be in very poor condition with severe deterioration of the adjacent wood soffits and trim elements. Rubber roofing membrane appears to have been added to line and/or cover over the gutters in an attempt to maintain the drainage system. The rubber roofing is improperly installed and does not appear to be effective. Plant growth has also been permitted to overtake the soffit and gutter at the northwest corner of the building, thus exacerbating the deterioration of wood elements.

Deteriorated soffit at built-in gutter at west elevation. View looking east.

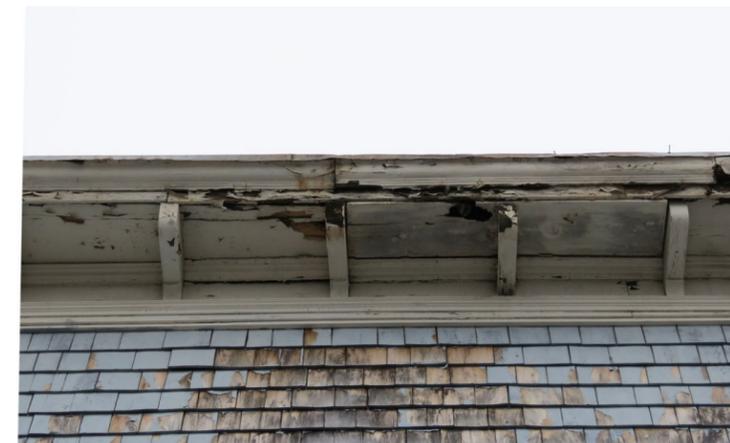
Deteriorated wood at soffit of built-in gutter at south elevation. View looking north.

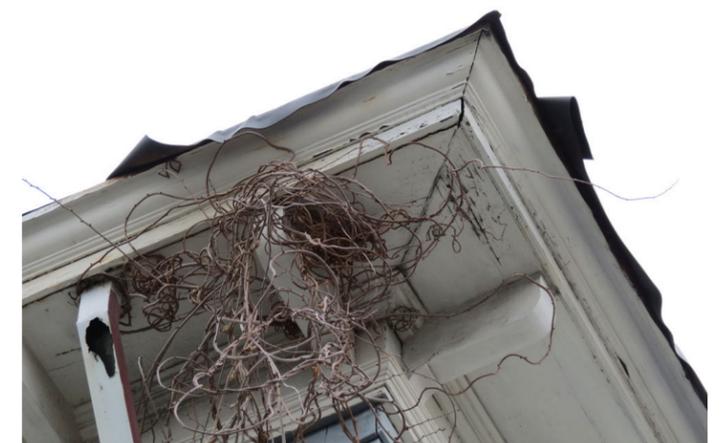
Rubber roofing membrane and plant growth at gutter of northeast building corner.

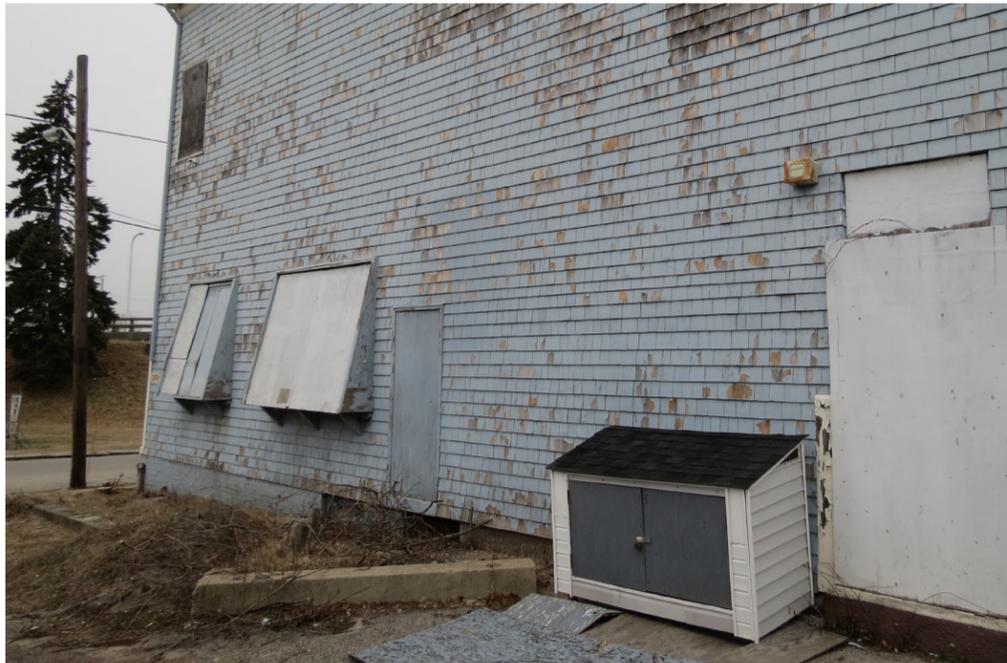
The exposed brick foundation wall is in poor condition and exhibits cracks as well as open mortar joints. The paint coating is failing. The grade surrounding the foundation varies in height and is very high and close to wood elements at the southeast corner.

High grade at south elevation. View looking northwest.

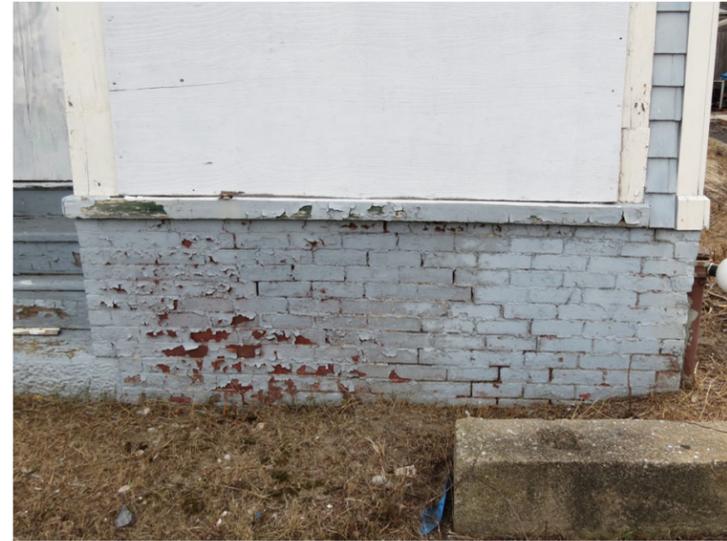
Deteriorated mortar joints and peeling paint at brick foundation wall. View looking at west elevation at southwest corner.

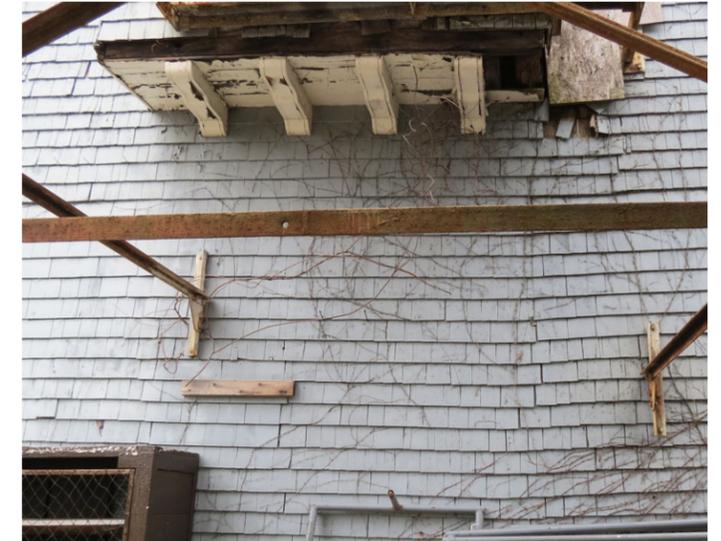
The painted wood shingles are in extremely poor condition and are beyond their life expectancy. The shingles are warped, cupped, split and, in some cases, missing. There is one area in particular on the east elevation where the deformation of the shingle coursing indicates a potentially troublesome concealed wall framing and foundation condition.

Deformed, warped and missing wood shingles at east elevation. View looking west.

Remove the existing cedar shingle siding and replace with new cedar shingle siding to match the existing. As part of this task, exterior wood trim should be replaced and restored.

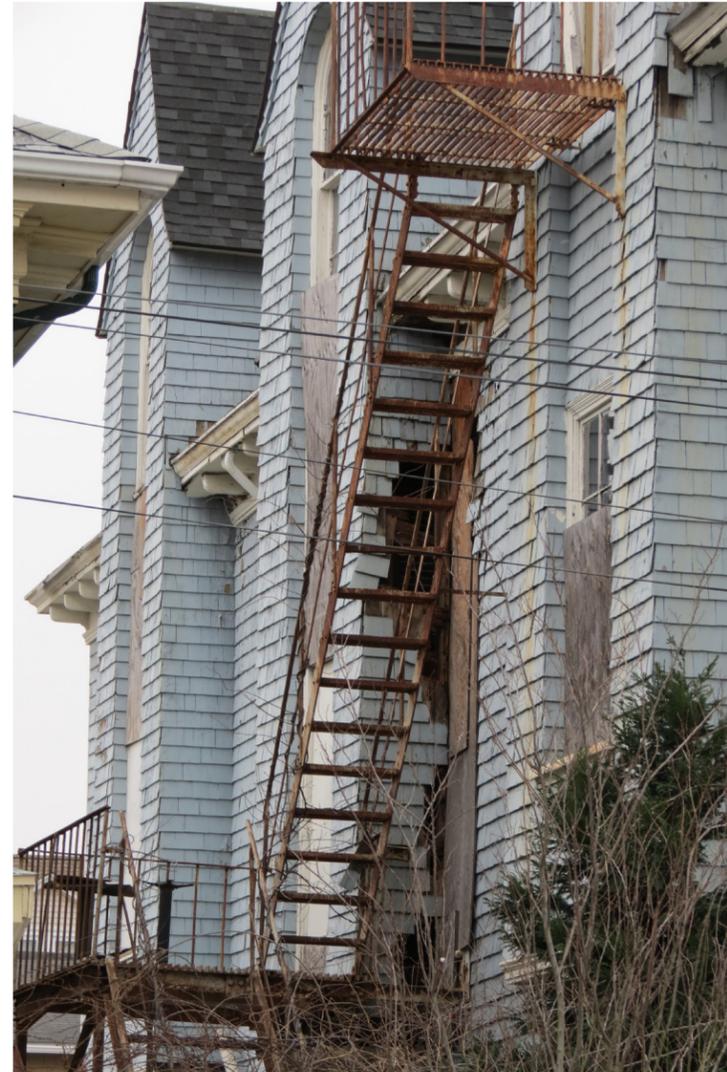
Deteriorated shingles at east elevation. View looking south.

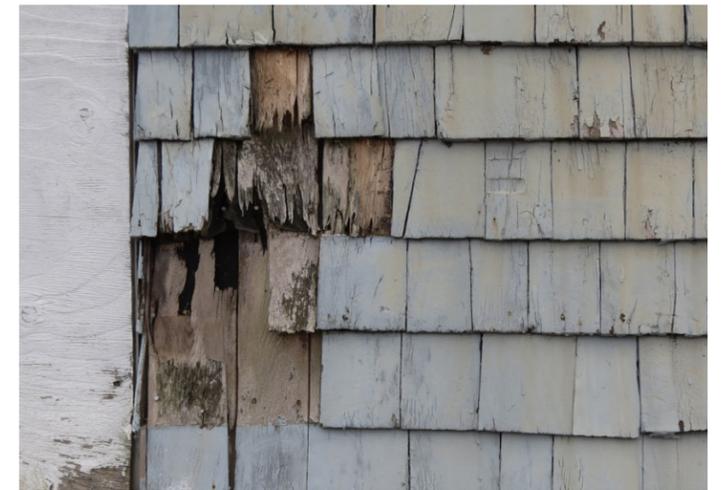
Deteriorated shingles and sheathing at west elevation. View looking east.

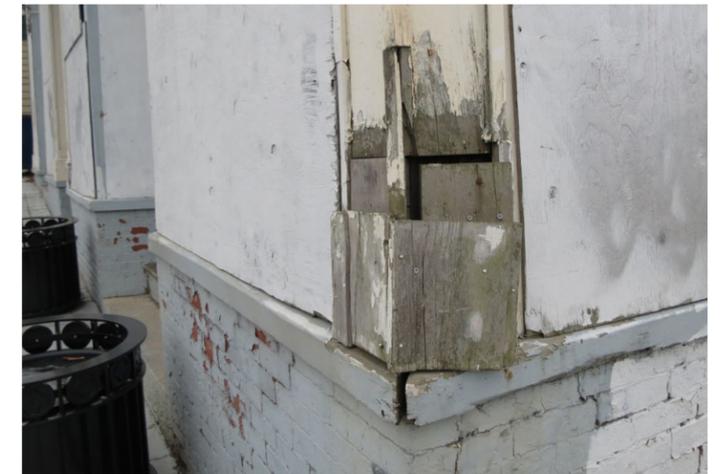
The wood trim on the exterior of the building is severely deteriorated due to lack of maintenance and water damage.

Deteriorated corner board trim at storefront. View looking at northwest corner of building.

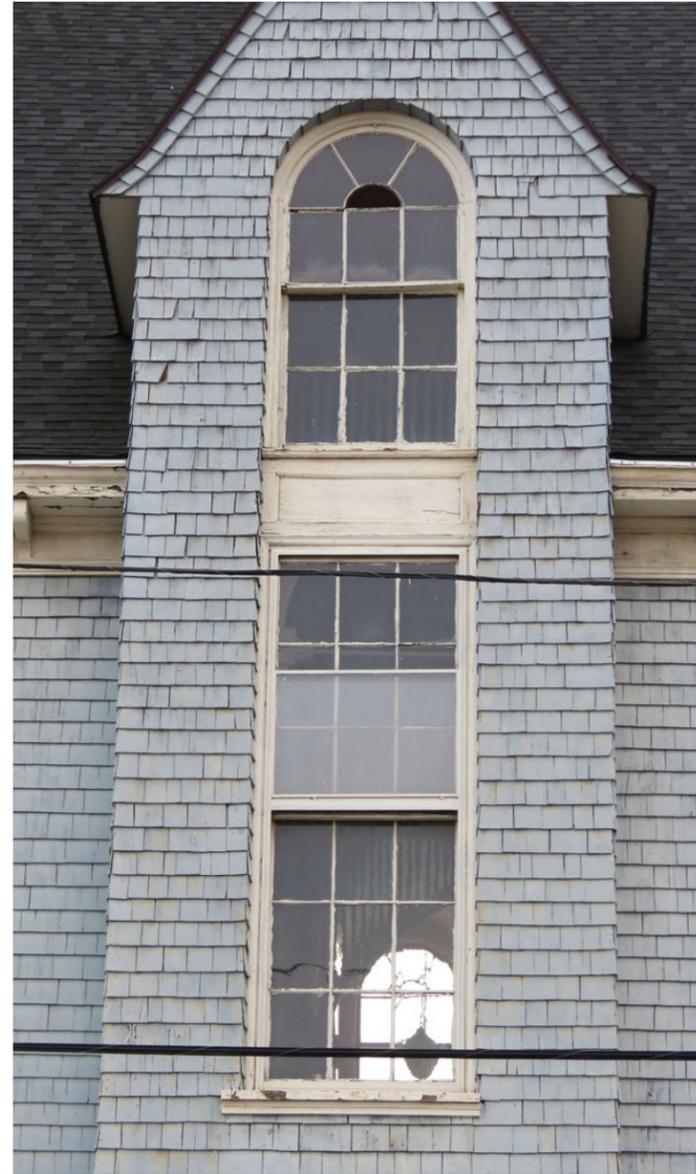
The social hall windows arranged in a double-height pattern with spandrel panels between the second and third floors are in very poor condition with much deteriorated wood and broken glass.

Detail view of two-story windows at second floor social hall. View of west elevation looking east.

Restore the existing wood windows and add low-profile storm panels. (Restoration of the wood storefront is not included under this task.)

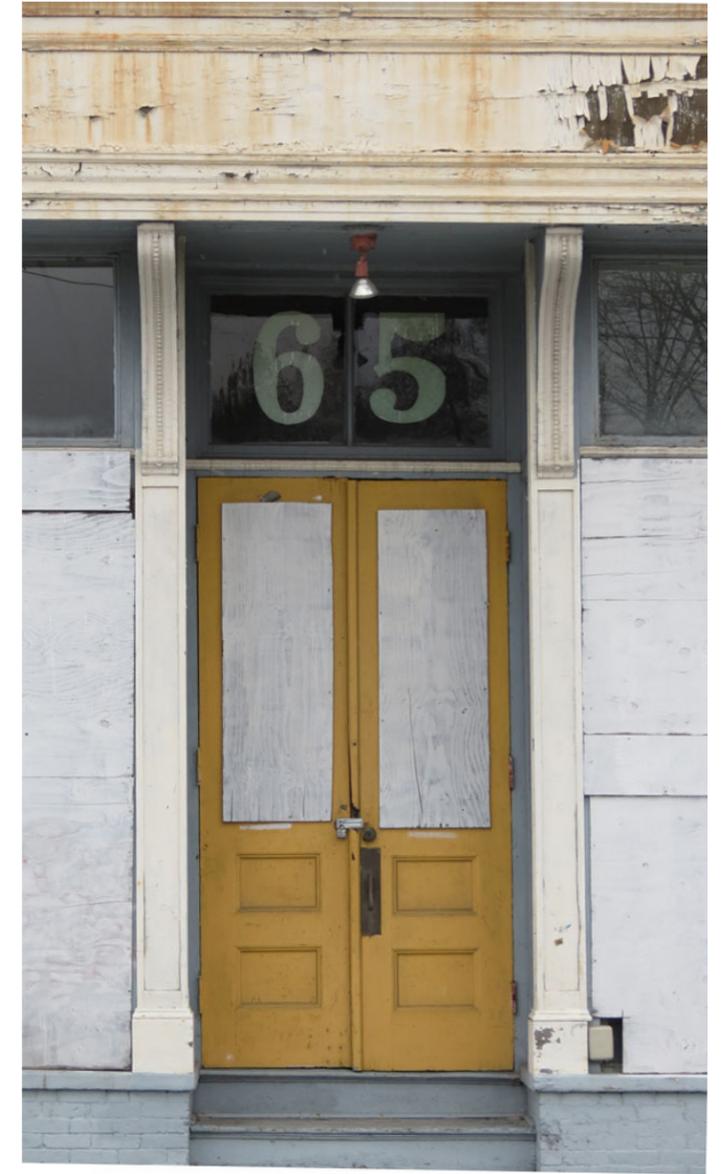
The only original exterior door remaining appears to be the center door of the north elevation, leading to the second floor stair. This door is in fair condition, with plywood covering the glass lights. All of the other doors have been replaced, removed or boarded over.

Original center door at storefront leading to stair to second floor. View at north elevation looking south.

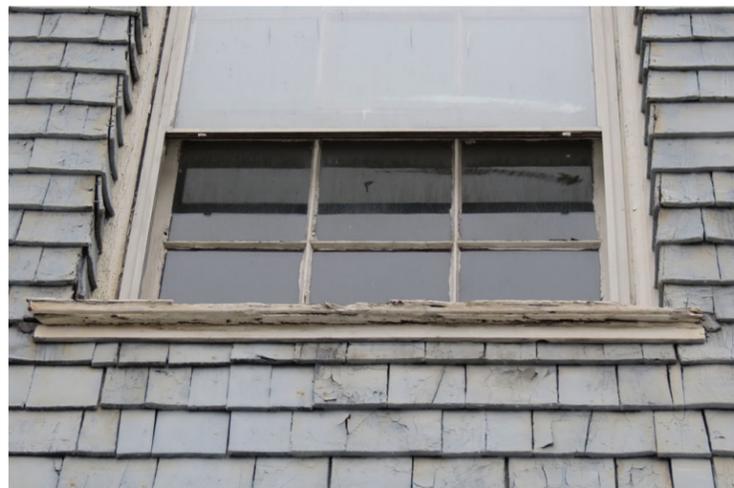
Individual wood windows are in fair to poor condition and do not offer much thermal protection as they are single-glazed. Some windows are covered by aluminum storm windows, but the storm windows are in very poor condition where they exist. Many window sills are in poor condition.

Typical deteriorated sill at two-story window. View of west elevation looking east.

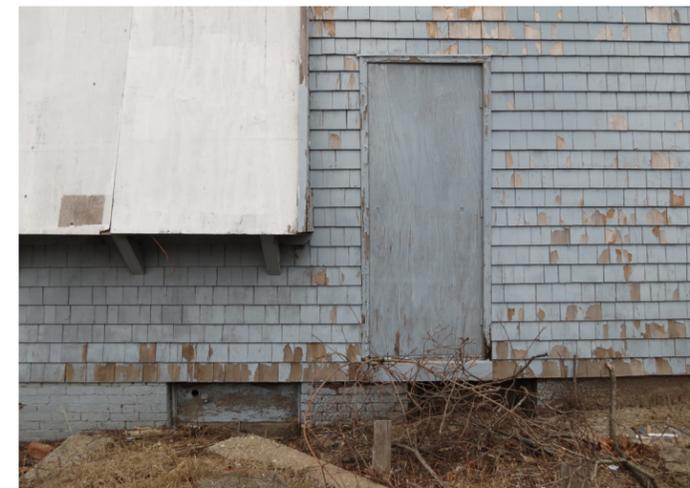
Original egress door at south elevation boarded over. View looking north.

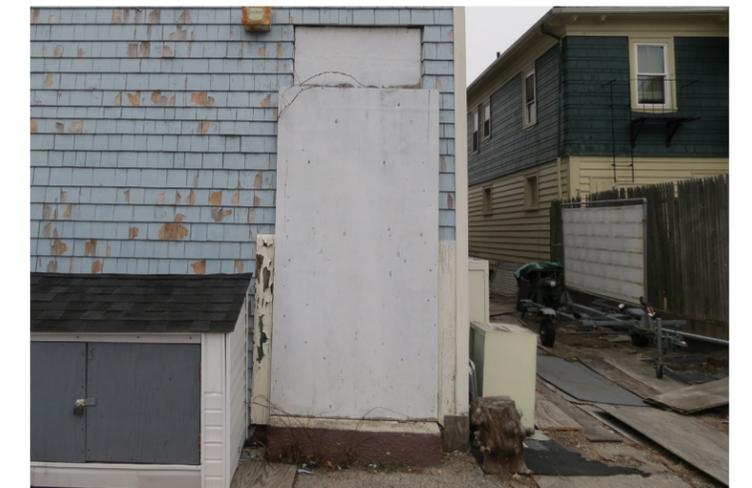
Original egress door at south elevation boarded over. View looking north.

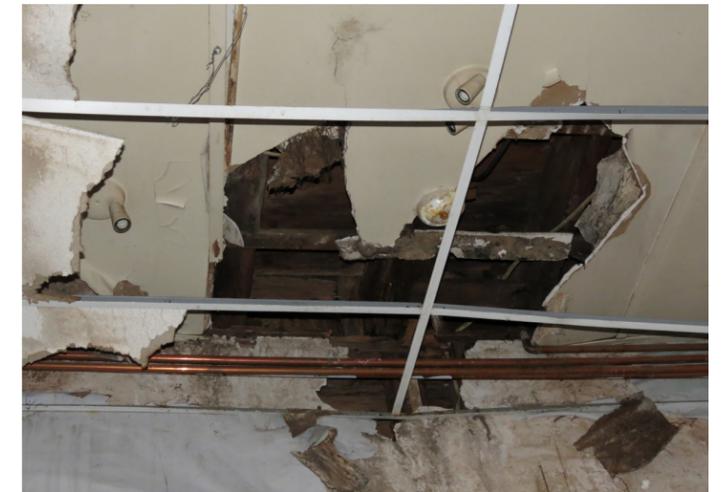
The original plaster ceilings have been severely damaged by water and later alterations.

Detail view of multiple ceiling layers and water damage at east side of first floor.

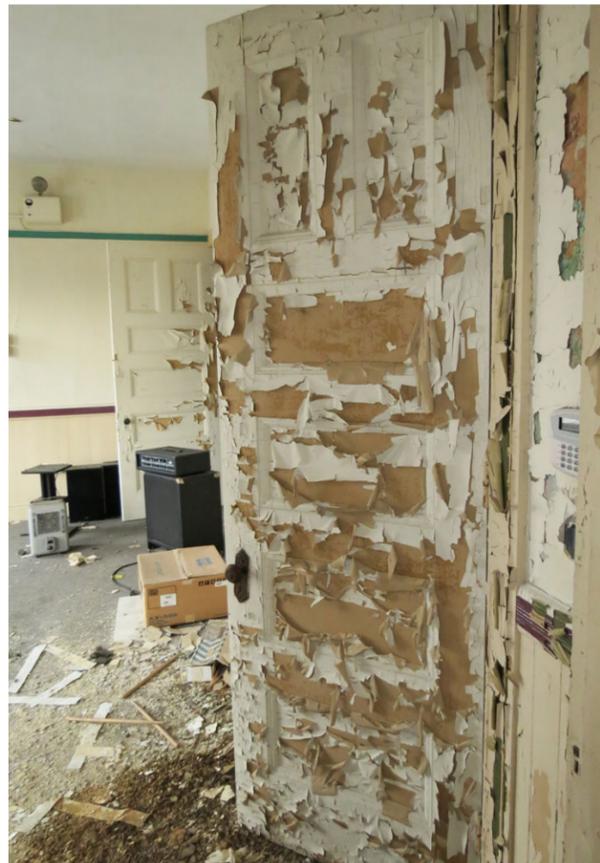
The original interior doors vary in condition from very poor and water damaged to good. There is extensive paint failure at much of the woodwork due to the fact that there has been extensive moisture infiltration and the building is not heated.

Original door at second floor office damaged by water.

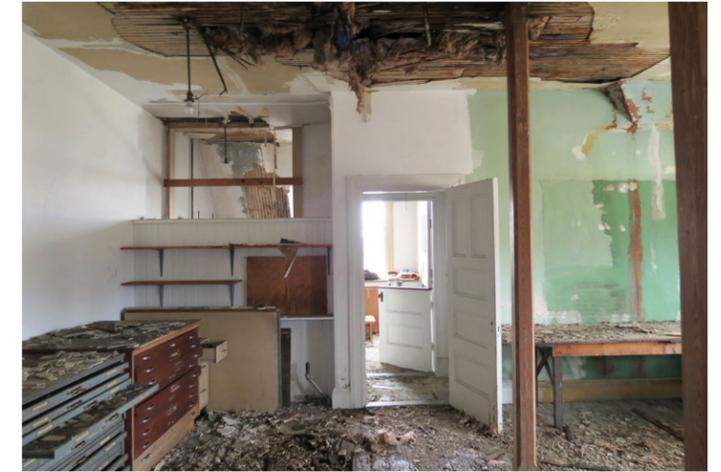
The original plaster ceilings have been severely damaged by water infiltration and are in extremely poor condition.

Damaged interior finishes at third floor office space. View looking west.

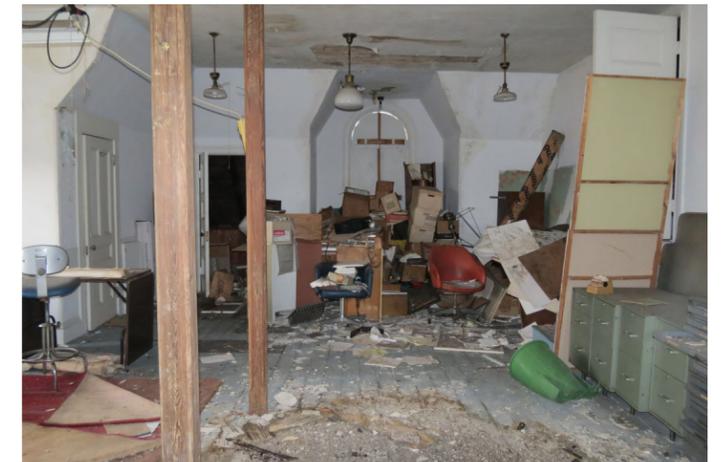
Damaged interior finishes at third floor office space. View looking east.

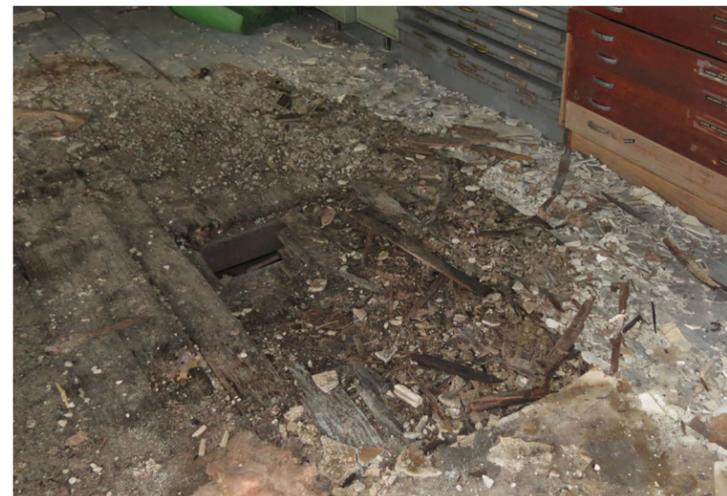
The wood flooring and framing has been severely compromised by water infiltration and has failed in a large area, creating a very unsafe condition.

Detail view of damaged flooring at third floor office space.

At the second and third floors, reframe and replace floor and ceiling members where they have been compromised by water infiltration. This temporary repair is intended to create a safe condition until a full structural evaluation can be undertaken and until a new use for the building has been determined.
