Odd Fellows Hall

63-65 Warren Avenue, East Providence, RI
Historic Structure Assessment

June 2014

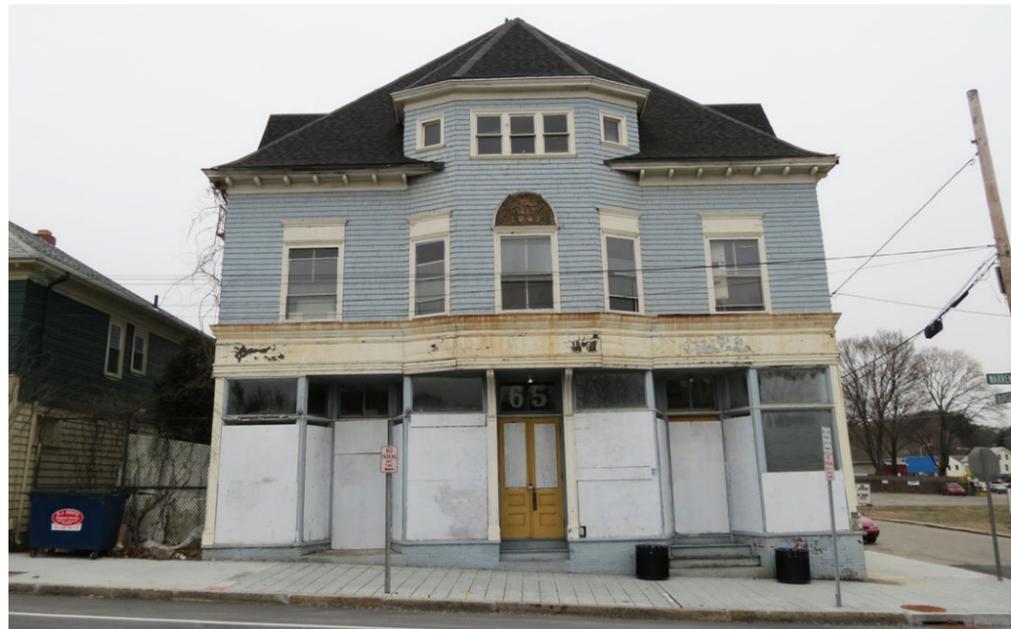
Original storefront at first floor (boarded over) with office space above. View of north elevation looking south.

The wood storefront has been boarded over, but appears to be in fair condition as viewed from the inside.

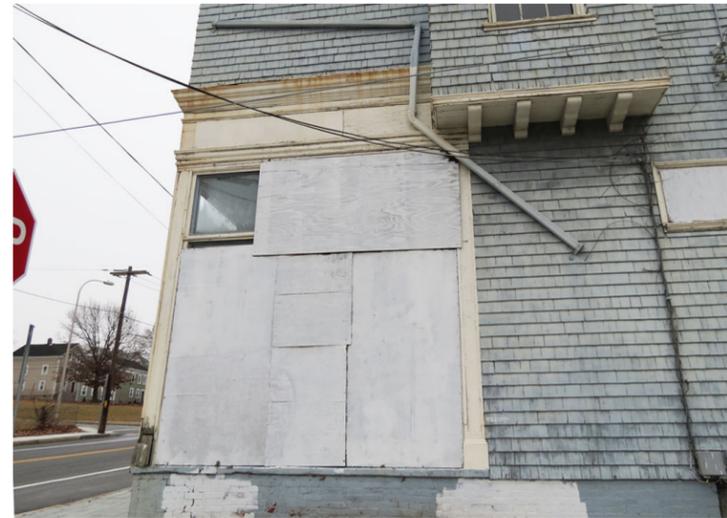
Original storefront boarded over at north end of west elevation. View looking east.

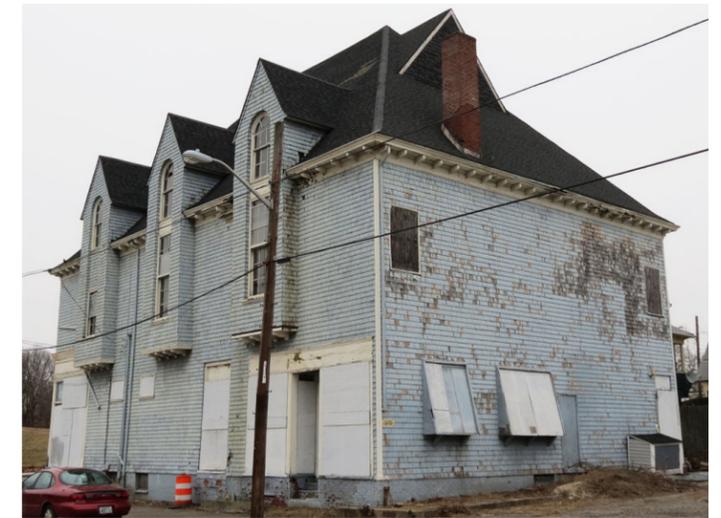
Side elevation storefront and two story windows at second floor social hall. View of south and west elevations looking northeast. Note non-original projecting windows at south elevation.

The projecting windows boarded over at the south elevation are not original to the building and detract from the historic character of the building. They are also in poor condition.

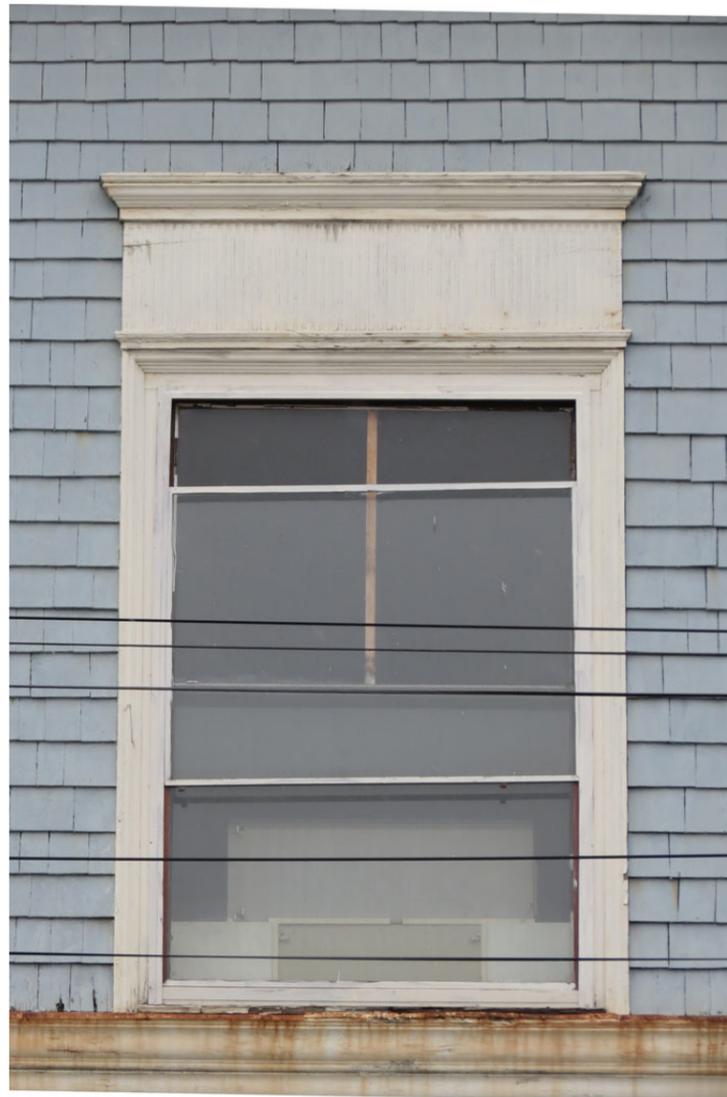
Original two-over-one wood window at second floor. View of north elevation looking south.

Individual wood windows are in fair to poor condition and do not offer much thermal protection as they are single-glazed. Some windows are covered by aluminum storm windows, but the storm windows are in very poor condition where they exist. Many window sills are in poor condition.

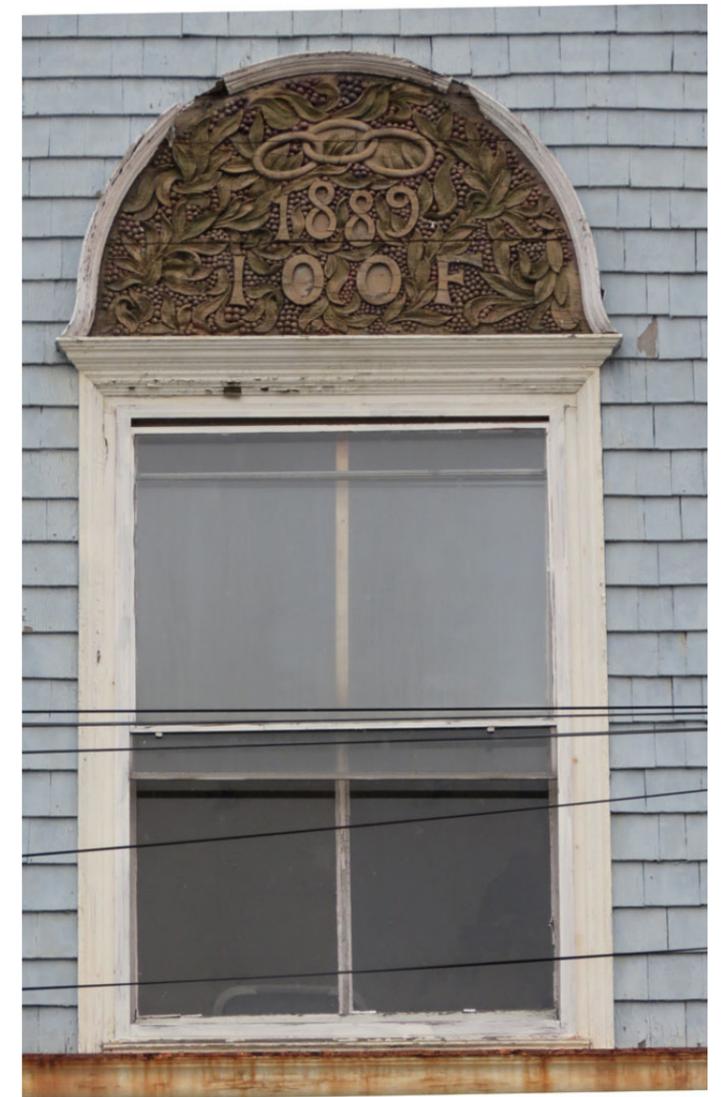
Original two-over-two wood window at second floor. View of north elevation looking south. Note decorative window hood.

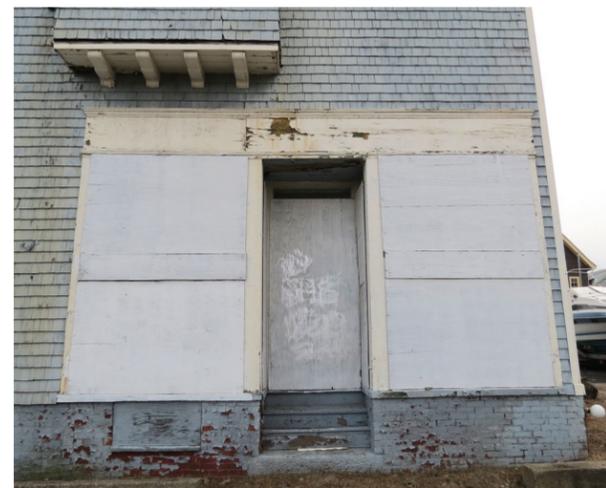
Secondary storefront entry at southwest corner of building. View of west elevation looking east.

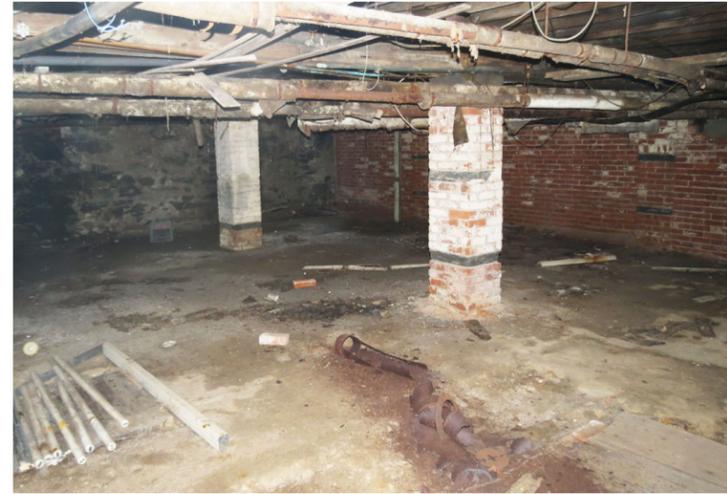
There is evidence of moisture penetrating the perimeter stone foundation walls.

The concrete floor slab is in poor condition.

View of main basement area looking southeast.

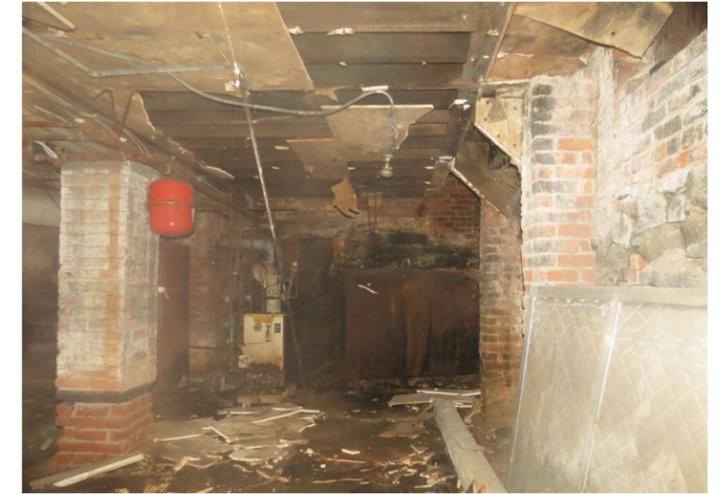
View of secondary basement area looking south.

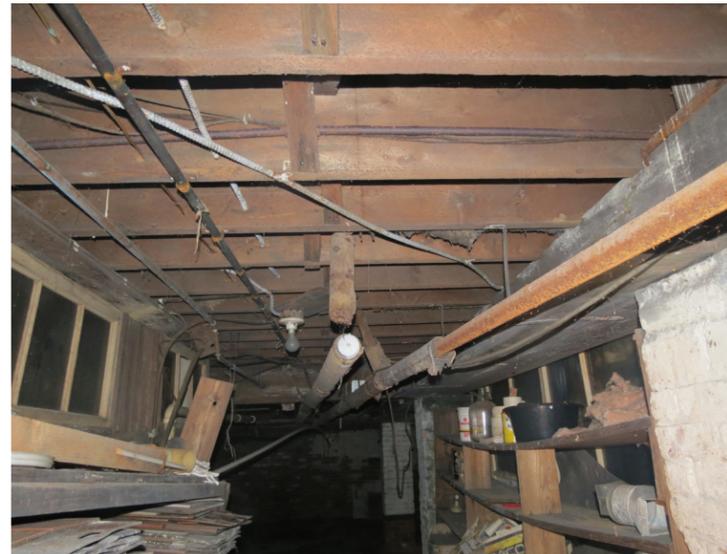
The wood framing of the first floor is in fair condition.

View of main basement area and first floor framing looking south.

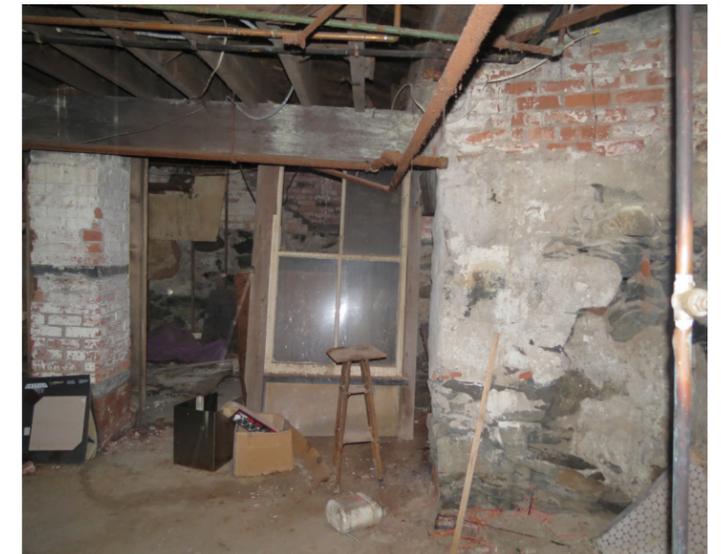
View of main basement area looking west. Note rubble stone foundation wall with brick above.

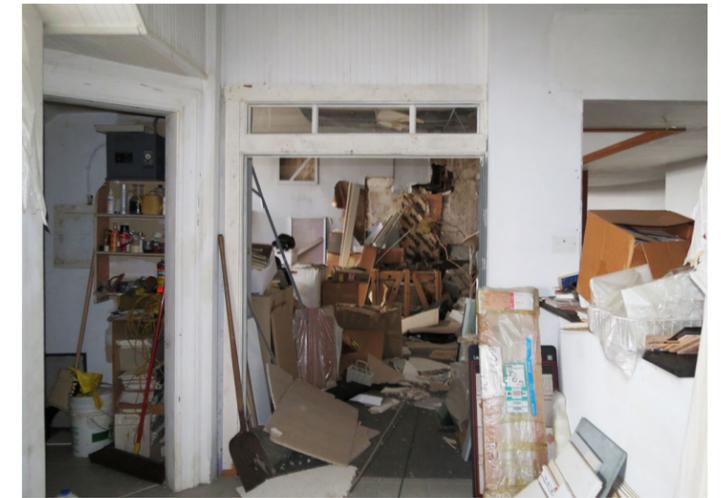
The original beaded board adjacent to the central stair is in fair condition.

View looking east from west side of first floor. Some trace evidence of beaded board remains adjacent to central stair.

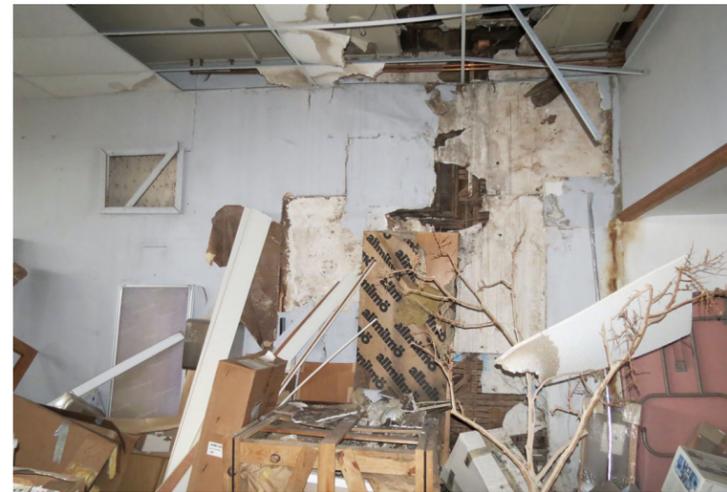
View of non-original finishes at east wall of first floor (east side of first floor).

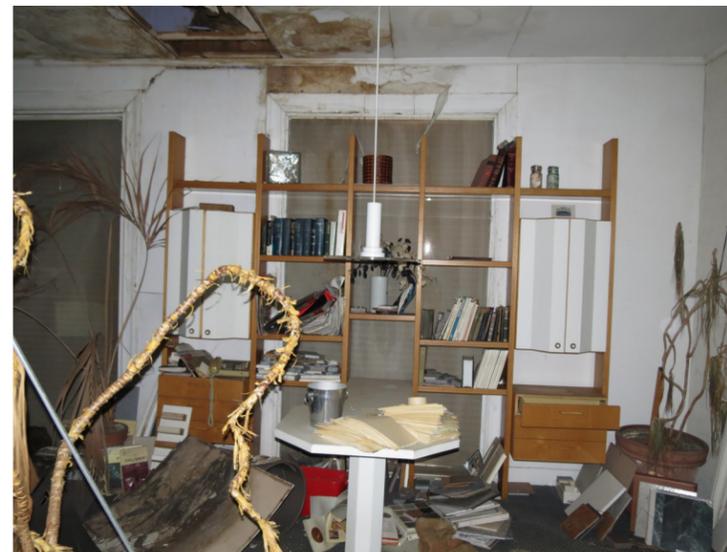
View of non-original finishes surrounding an original window at west wall of first floor.

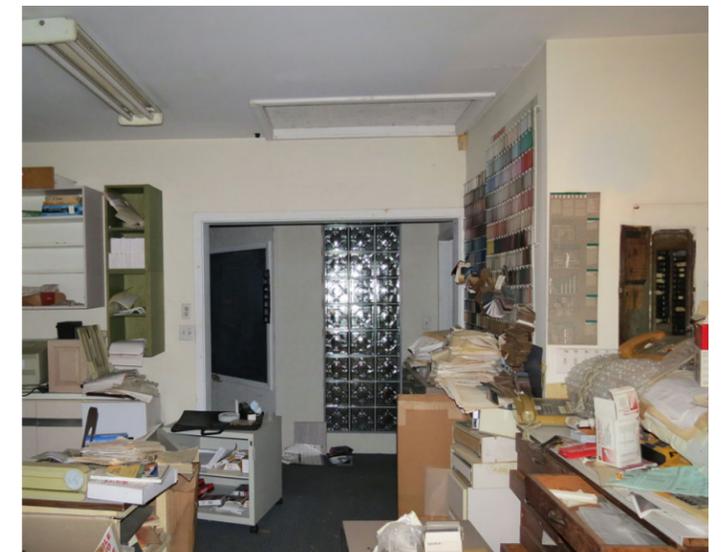
View of non-original interior finishes at east side of first floor.

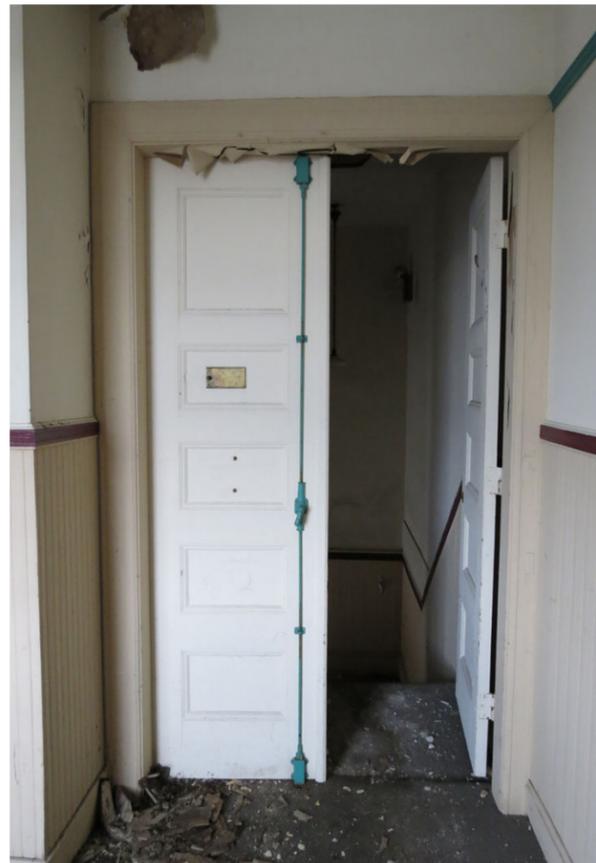
The original interior doors vary in condition from very poor and water damaged to good. There is extensive paint failure at much of the woodwork due to the fact that there has been extensive moisture infiltration and the building is not heated.

Original wood door at second floor on good condition.

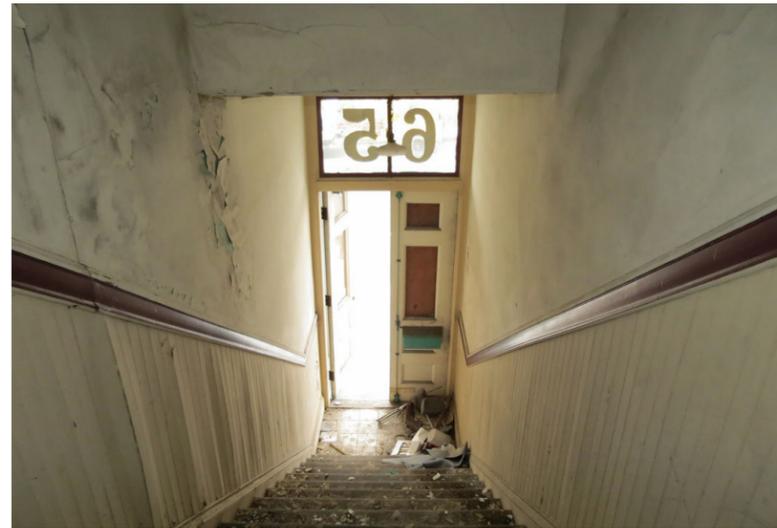
Original wood wainscoting varies in condition from very poor in the stair hall to good in the social hall.

The stairs between the first and second floors are in fair condition and do not appear to meet current building and life safety codes.

Original plaster and wainscot finishes at stair to second floor. View looking north.

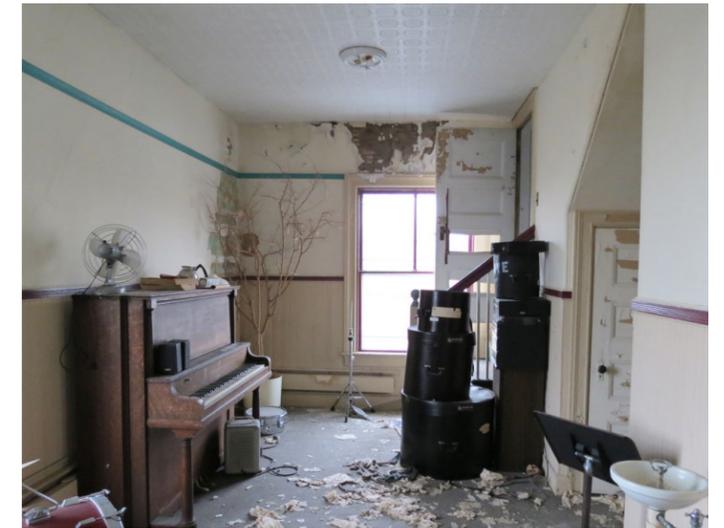
Plaster walls vary in condition. They are in fair to poor condition in the social hall but exhibit severe water damage in office and lobby areas.

Original plaster and wainscot finishes at second floor lobby. View looking north.

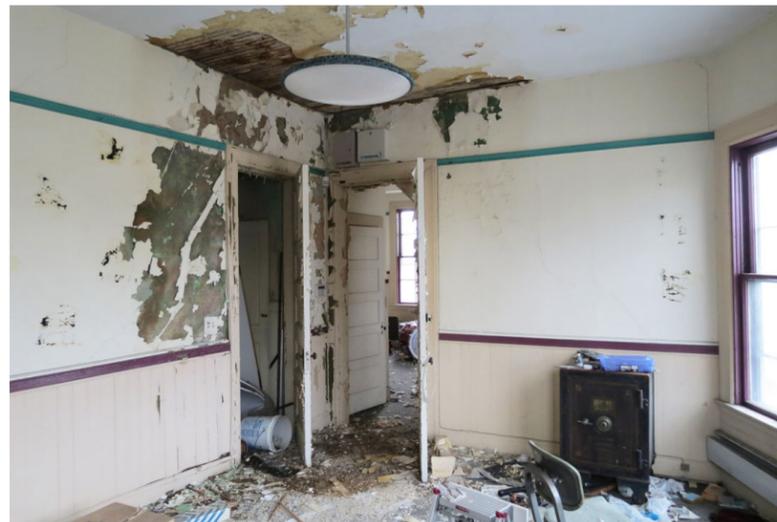
Original plaster and wainscot finishes at second floor office space. View looking west.

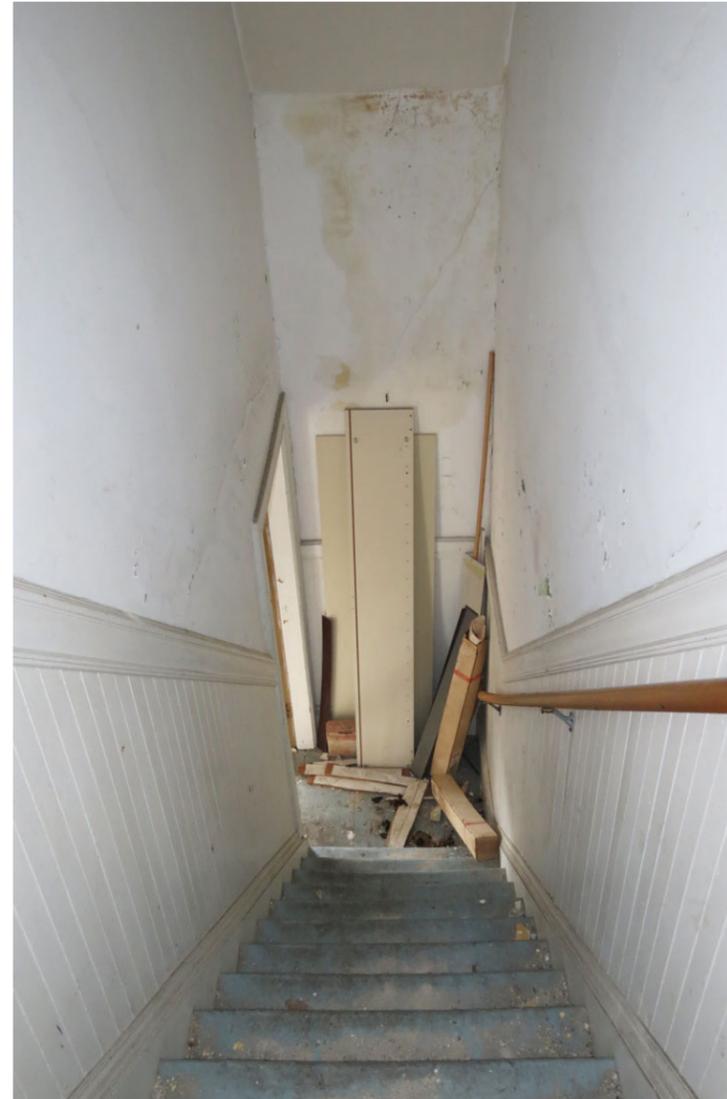
The stair between the second and third floor is in fair condition, but does not appear to meet building and life safety codes.

Original plaster and wainscot at stair between second and third floors. View looking north.

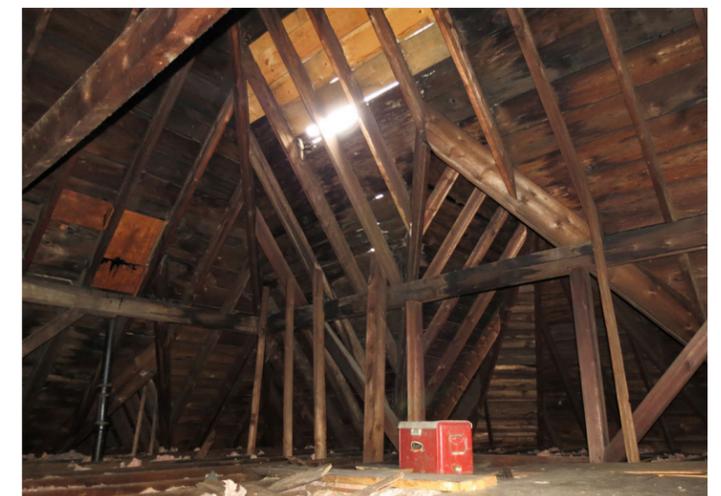
The floor framing members appear to be in fair condition.

The roof decking shows signs of significant water damage and previous repairs. There are sections of roof decking that are not sound and daylight is visible where the roof covering has blown away.

View of attic space looking northwest.

Remove the existing asphalt shingled roof and all deteriorated roof decking. Infill roof decking as required and install new plywood roof sheathing over the entire roof. Install new laminated asphalt shingles. As part of this task, the wood gutters should be restored and all flashings and rain leaders should be replaced.
